FINAL REPORT

EVALUATION OF LOAD TRACKS AND WEAR OF  
TWO SETS OF BEARINGS FROM SPACE SHUTTLE  
MAIN ENGINE HIGH PRESSURE OXYGEN TURBOPUMPS  
(Contract No. NAS8-36192, Task 118)

J. W. Kannel and K. F. Dufrane

BATTELLE  
Columbus Division  
505 King Avenue  
Columbus, Ohio 43201-2693

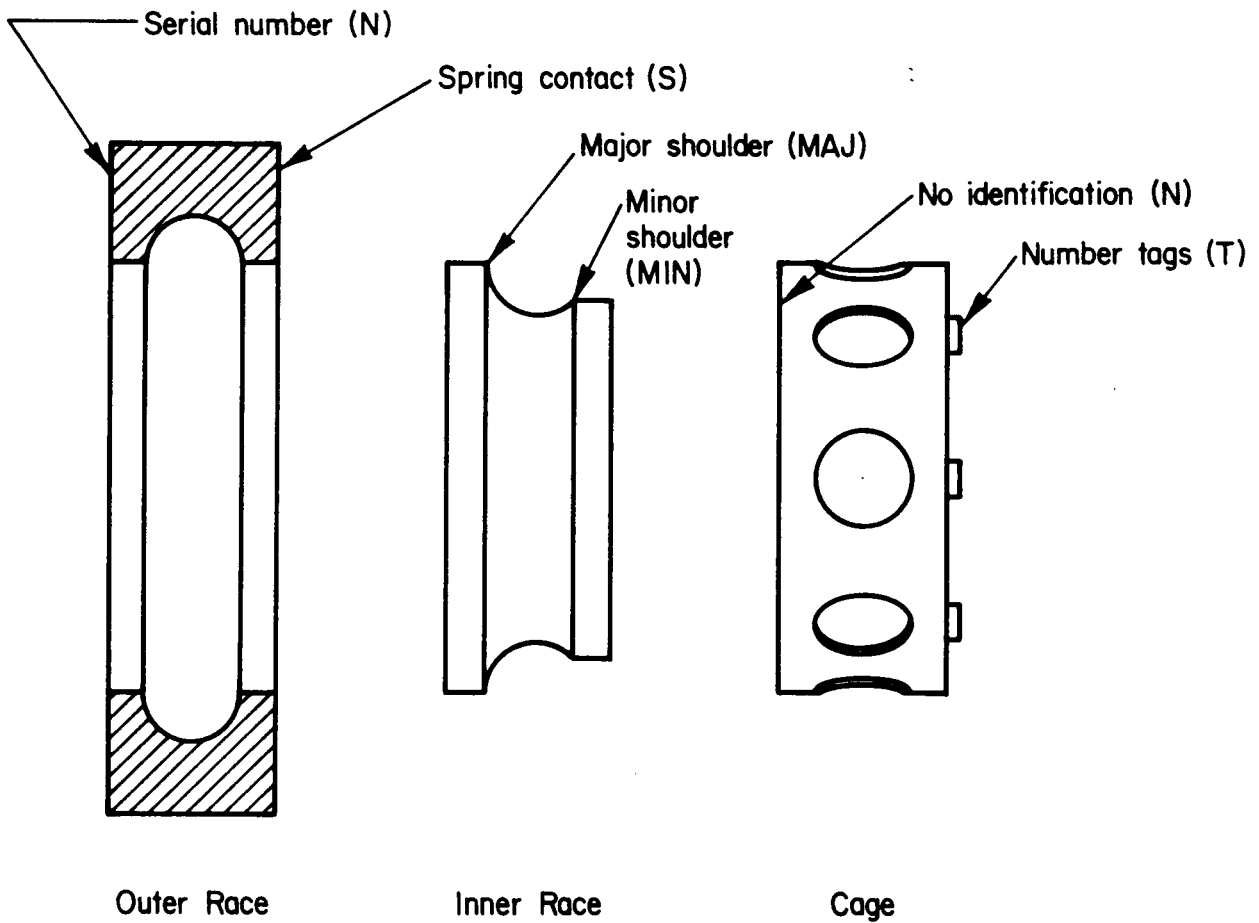
FIGURE 1. IDENTIFICATION NOMENCLATURE

Table 1 summarizes the specific observations made by the examining team. Figure 1 shows the identification nomenclature. Two bearings (2 and 4) on Unit No. 2317R1 were badly degraded. Bearing No. 2 (preburner side) had evidence of pitting (or flaking) on the inner race and evidence of wear on the outer. The outside of the outer race showed evidence of galling near the N side, which was probably the result of spinning relative to the housing. Cage pocket wear on the No. 2 bearing was fore and aft in the pocket and on the side of coolant flow, which would expected.
